# The Continuing Evolution of the Breach at Old Inlet

Charles N. Flagg and Roger D. Flood

School of Marine and Atmospheric Sciences, Stony Brook University

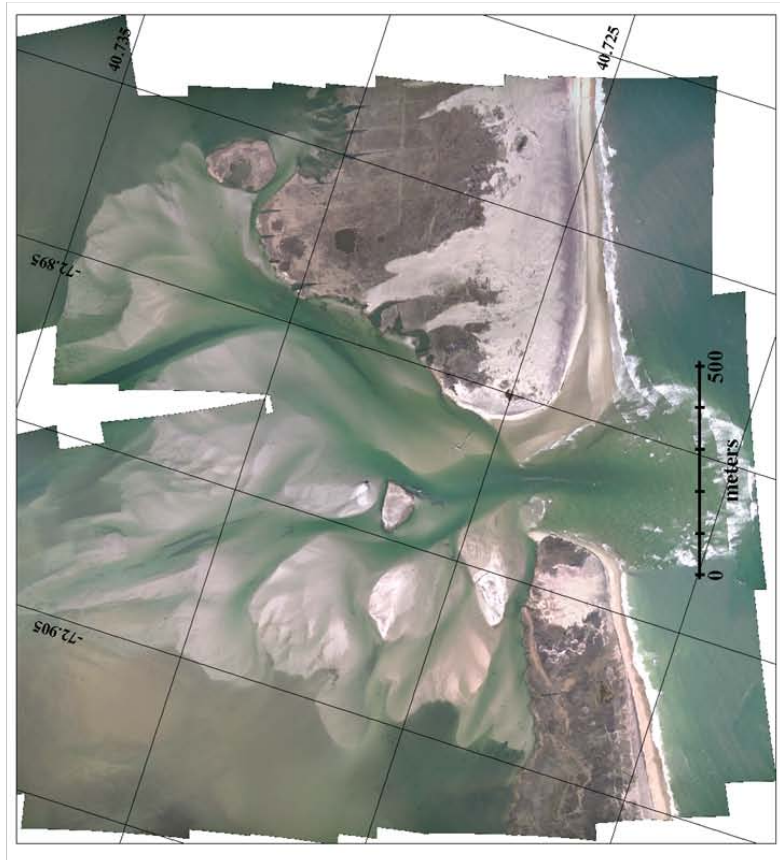
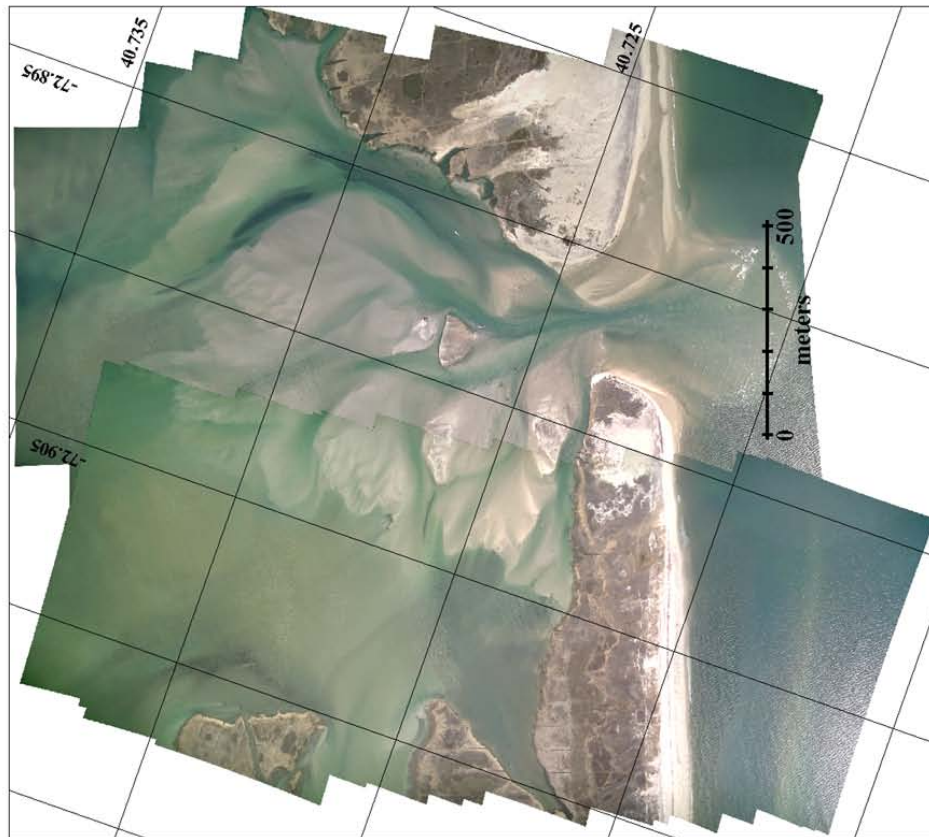
**Figure 3, Photo mosaics from March 29 and April 17, 2013**

The photo mosaic taken on March 29, Figure 3, is quite similar to that of March 10 in the previous report, although the shoaling in the channel to the west just north of Fire Island has increased. Also by the end of March the sand bar that had moved into the inlet along the eastern side had increased in size and consolidated. Evident in the March 29 and subsequent photos is a runnel area between the eastern sand shoal and Fire Island to the east. This runnel area has waxed and waned over the past three months indicating that while the eastern sand shoal remains low enough to be flooded at times, it has not been accessible to overwash for enough sand to be deposited to fill the depression.

The major alterations to the inlet since the end of March involve the development of a sand spit off the northwest corner of the inlet. On March 29<sup>th</sup> there was just a small indication of a sandy area at the tip of the island. The spit grew noticeably by April 17<sup>th</sup> and the shoal at the entrance to the westward channel had grown as well essentially cutting off the channel along the north side of the island. By a month later on May 12<sup>th</sup> the spit had grown to an area of about 200 meters by 100 meters and reduced the western channel even further. At the end of May, the enlarged sand spit remained and one can see that flow to the west had formed a new channel north of the spit. The evolution of the spit continued into June when a small nor'easter on June 8<sup>th</sup> caused the erosion of the northern end of the spit evident in the June 16 photo, Figure 5. Some erosion of the spit had taken place on the west side, but most of it occurred in the inlet area. The sand however was not washed out of the inlet but rather built up an extensive shoal along the spit to the east. When we were out in the inlet for another bathymetric survey on June 21<sup>st</sup> during an ebb tide, the water was boiling over this shoal and it was quite shallow. While the spit on the west was eroded as a result of the June storm, an extensive shoal area formed along the east side of the inlet extending from the northeastern corner of the inlet southward highlighted by the breaking waves in that area in Figure 5.

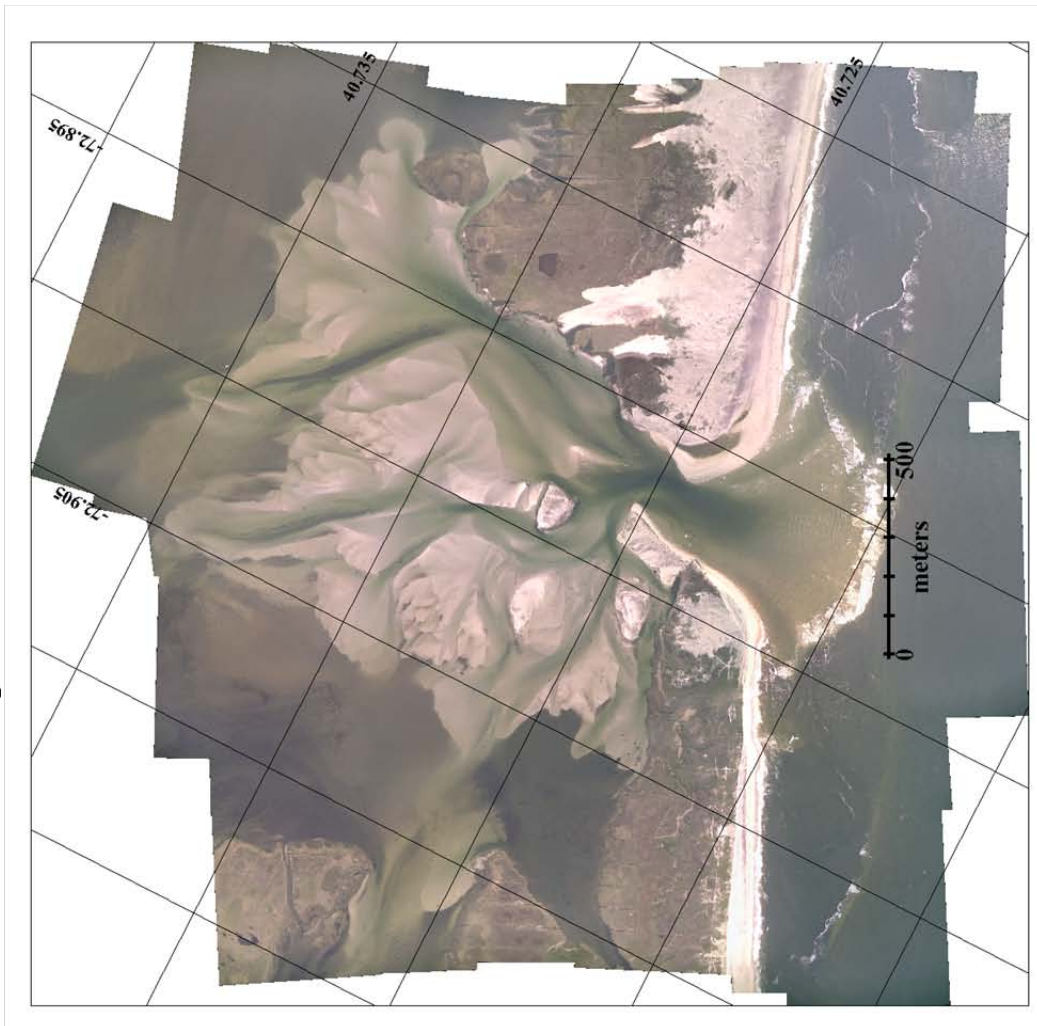
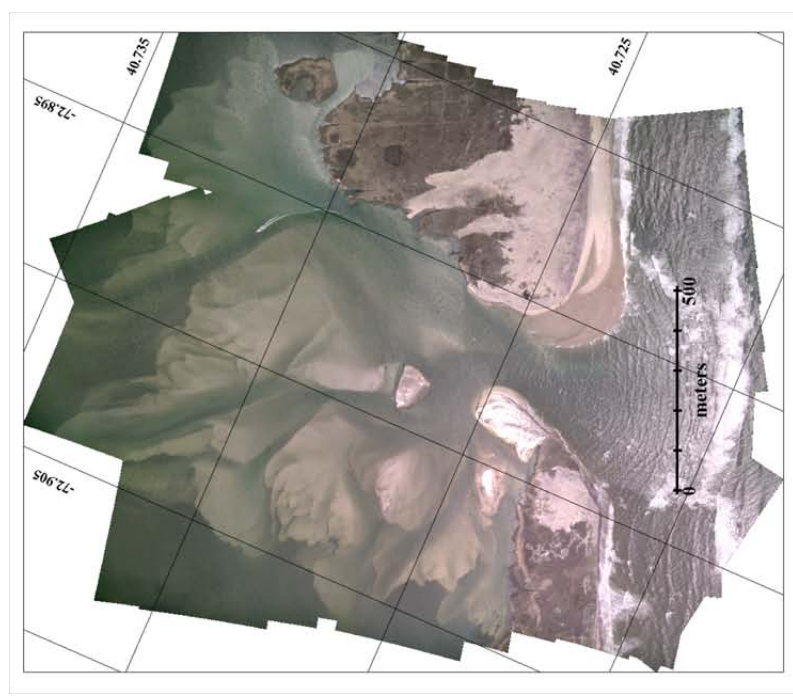
**Figure 4, Photo mosaics from May 12 and May 31, 2013**

The changes in the back bay sand island, shoals and channels have not been as dramatic as the changes in and along the inlet, but the evolution of that area continues. In particular, the channels and shoals off to the northeast keep changing. Since the storm at the end of February when the gun club house on Pelican Island moved about 100 meters to the north, the area under the house's previous location has been part of a major channel to the north and east. The channel on the west side of Pelican Island heading off to the north has also increased in size. Early on in the development of the inlet, the main channel to the east skirted along the north shore of Fire Island. That channel has varied in size and location. Initially it was south of the Old Inlet dock about which a sand shoal had formed. But later that shoal shifted and spread out to the east, and there is now considerable flow through the old dock. Much of the flow to the north and east is now funneled into an area along the Fire Island shore near Hospital Island, the little round island located at 40.732°N, 72.892°W. From there the flow splits, some of it spreads out and flows off toward the Smith Point Channel and some flows to the northwest, west of John Boyle Island.

Also notice that by the end of May the ocean beach to the west of the inlet had built up considerably and that this sand accretion extended along the west side of the inlet and has remained.

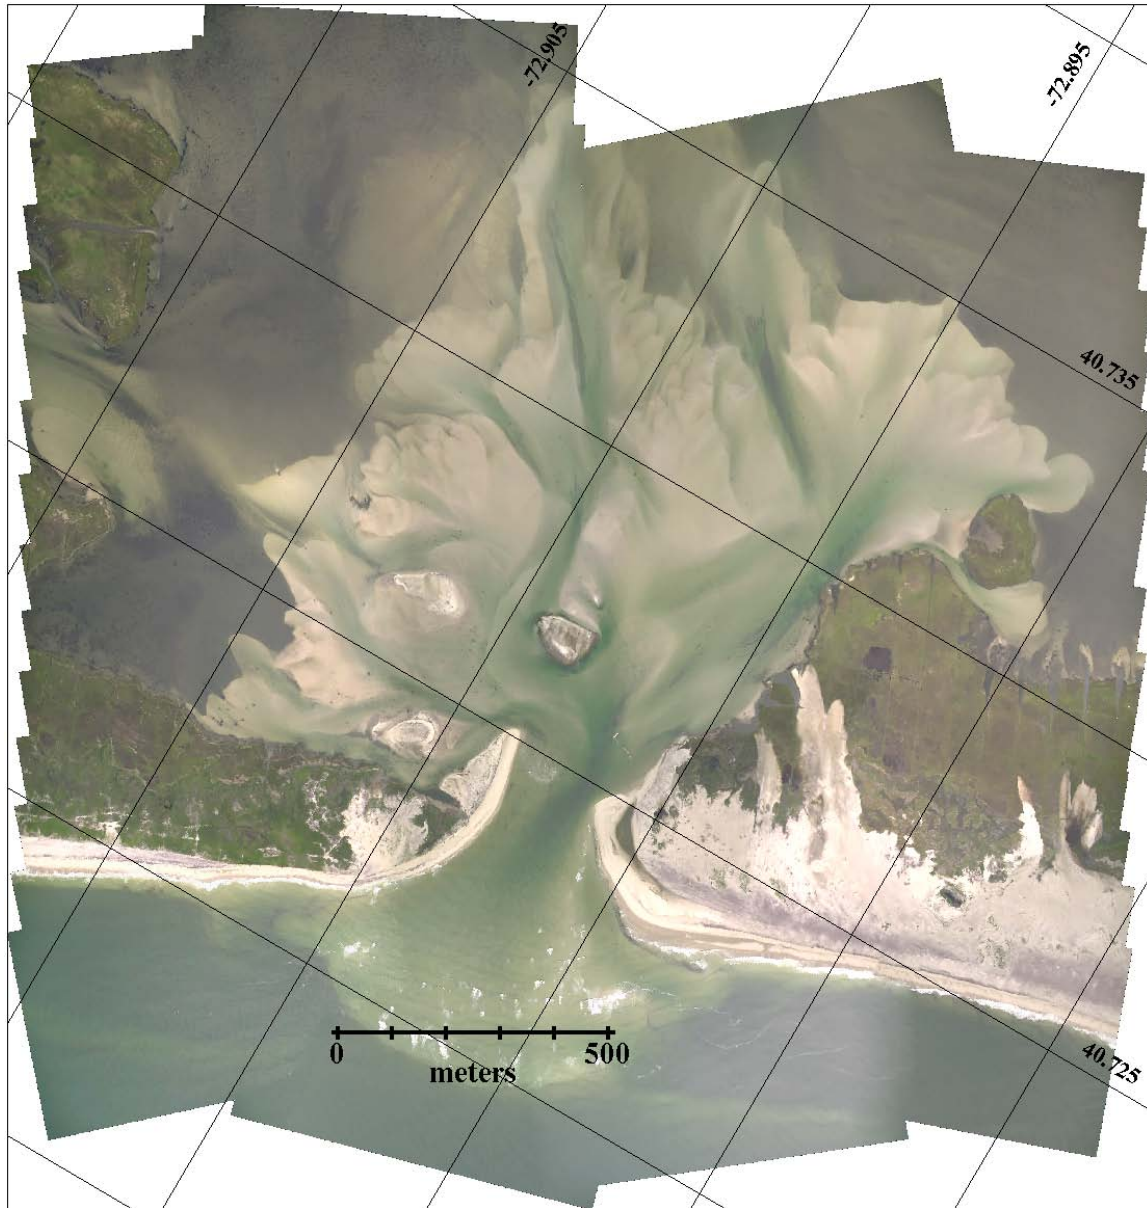
**Figure 5, Photo Mosaic from June 16, 2013**

On June 15<sup>th</sup> the remains of the displaced gun club house were removed. When it moved off the island on February 28<sup>th</sup> it sank in several feet of water and caused the flow in that area to slow down and deposit sand around the house. So a shoal and sand island formed around the house which is visible in all the photos since then. However the photo taken on June 16<sup>th</sup>, Figure 5, the day after the house was removed, already shows that the sand shoal around the house was beginning to erode away.

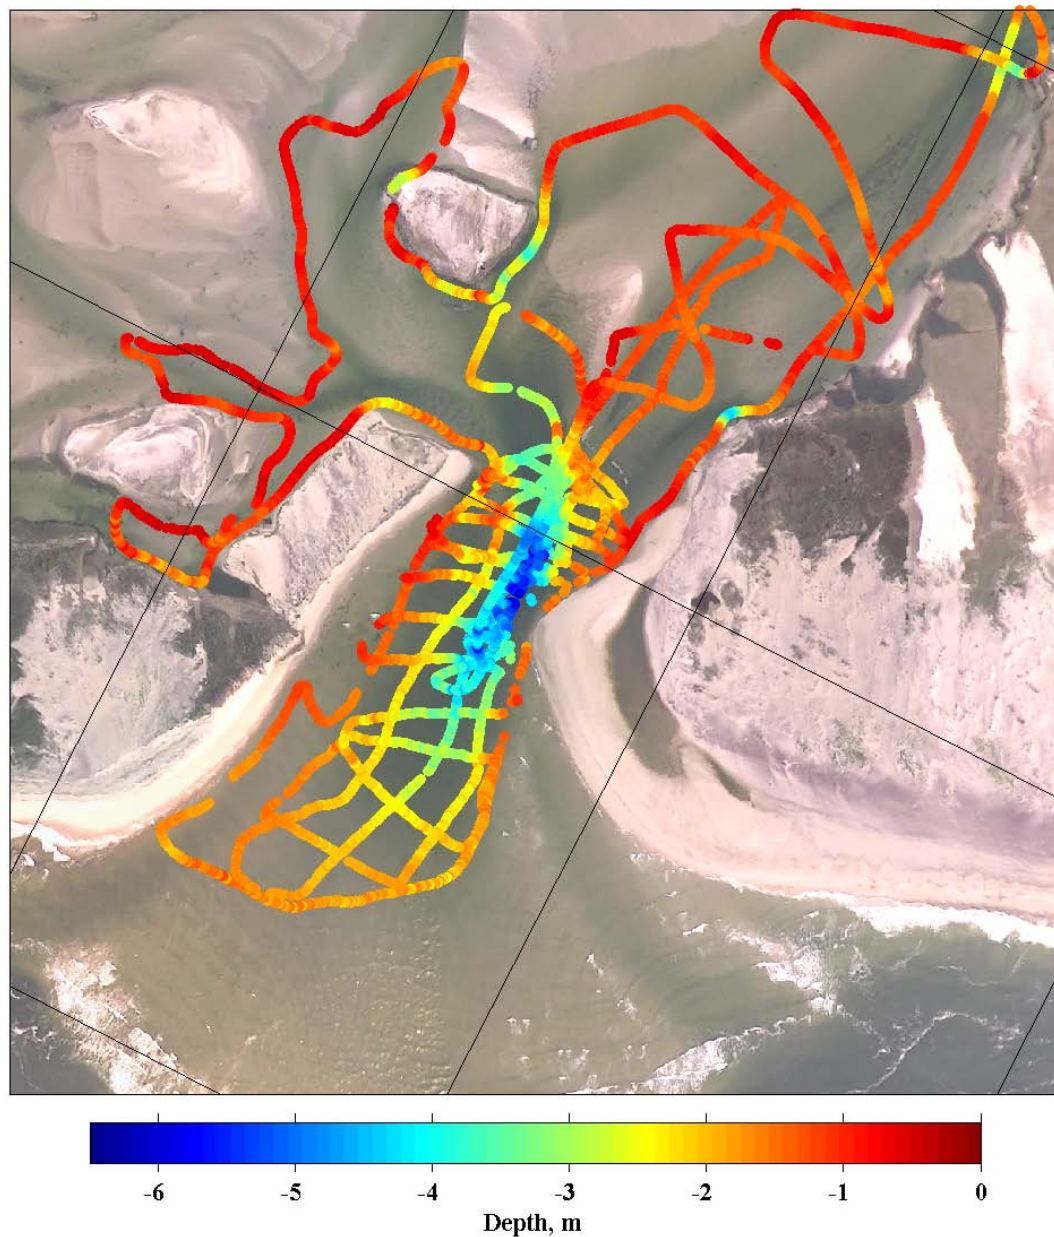
**Figure 6, Bathymetric data collected on May 30, 2013 plotted on the photo mosaic of the area from May 31.**

The bathymetric data in Figure 6 is characteristic of all the surveys we have done so far. There is a narrow throat region of the inlet where the depth is the deepest and the current the strongest. This throat area has moved generally westward since the inlet was formed while at the same time rotating from a cross-island orientation to lately, a more north-south orientation. The increasing northeast – southwest orientation of the inlet is characteristic of the progress of a natural breach as the combination of erosion on the west side and deposition on the east slowly rotates the inlet clockwise, as can be seen in the remnants of Old Inlet shown in the March 29<sup>th</sup> photo in Figure 3. To both the north and south of the throat area the flow spreads out, the erosion is less and the deposition greater so that the water depths become shallower. Water depths in those areas vary from 2 to 3 meters, to less than a meter. There now appears to be permanent islands to the west of the inlet while the shoals to the north and east often become dry at low tide.

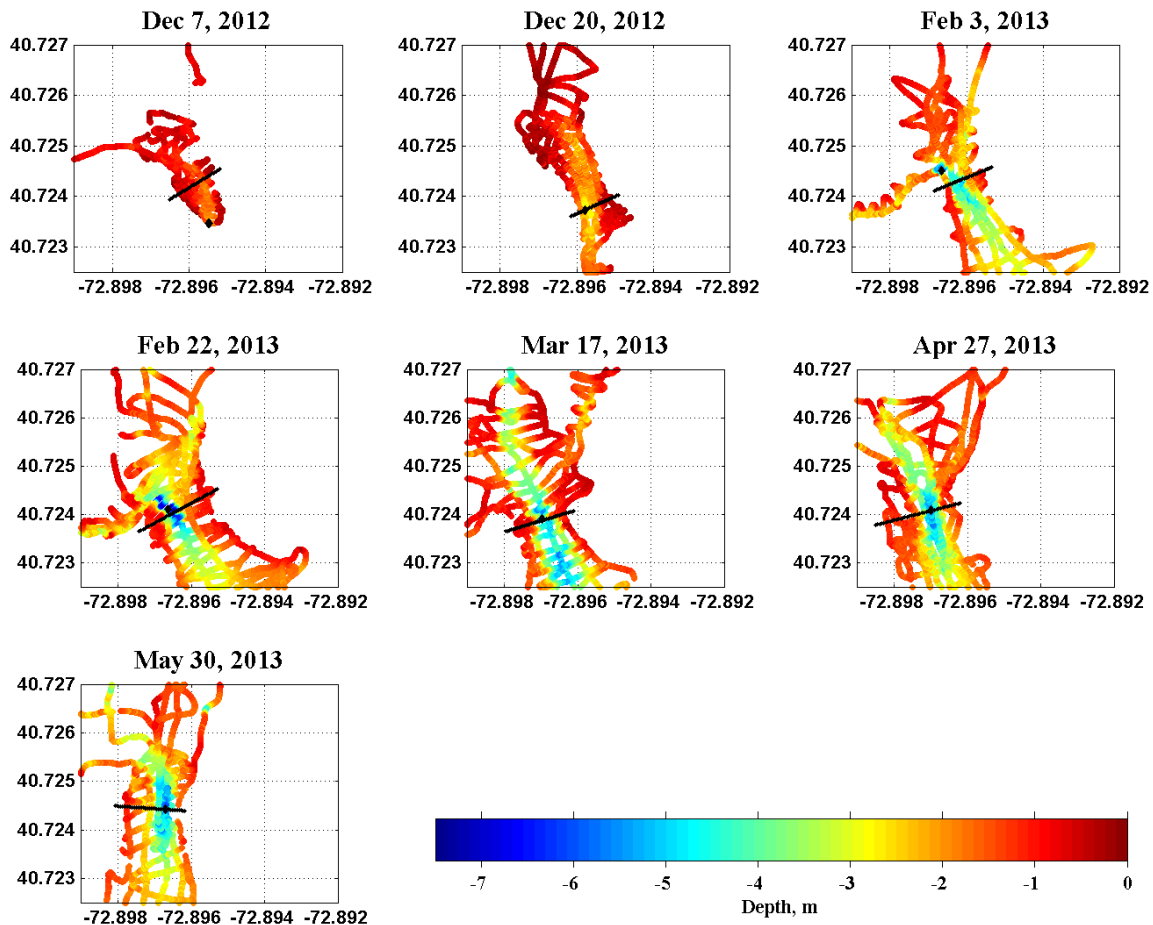
A summary plot of all the bathymetric data is presented in Figure 7 and it shows the early expansion of the inlet as well as the changes in its location and orientation. Through April, the orientation of the inlet remain pretty much directly across the island along a northwest to southeast line. The orientation changed in May, apparently as a result of sand entering the inlet along the east side forming a prominent shoal that is visible in the May 31 photo mosaic and even more clearly so in the June 16 photo. The north-south location of the deepest portion of the inlet has remained within about 50 meters of  $40.724^{\circ}$  N latitude, a position that seems to be related to the configuration of the east side of the inlet. Notice also that the deepest portion of the inlet generally extends less than 100 meters along the axis of the inlet.

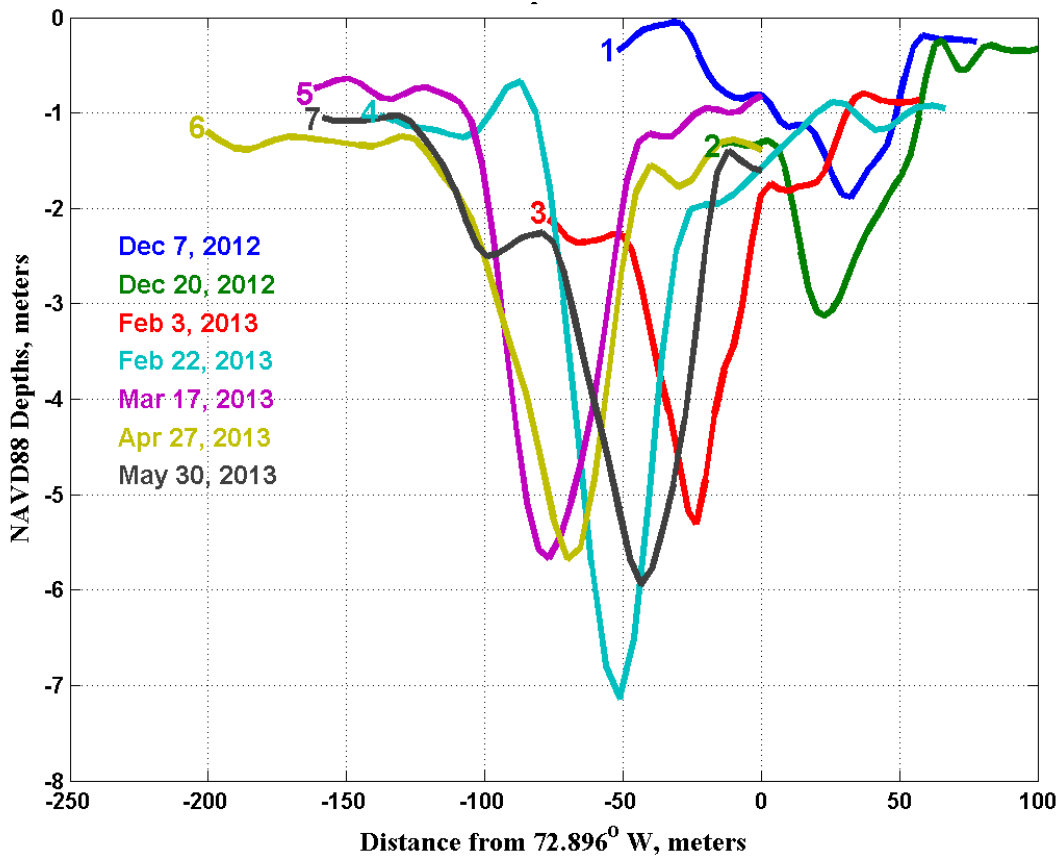
Figure 8, Cross-inlet profiles at the across the deepest portion of the inlet for each cruise.

Figure 8 shows the cross-inlet depth profiles at the locations of the deepest depths. The temporal progress of the inlet is clear in this view, showing both the westward movement and depth changes. The maximum depth increased from the initial ~2 meters to what appears to be a fairly stable 5 to 6 meters, although deeper depths occurred briefly in mid-February when somewhat more than 7 meters was observed. The plot shows that the throat of the inlet has moved about 100 meters to the west and was farthest west in mid-March. Since then the location of maximum depth has retreated back to the east by ~50 meters.
