Update on the Status of the Old Inlet Breach

Charles Flagg, Claudia Hinrichs, Roger Flood and Robert Wilson

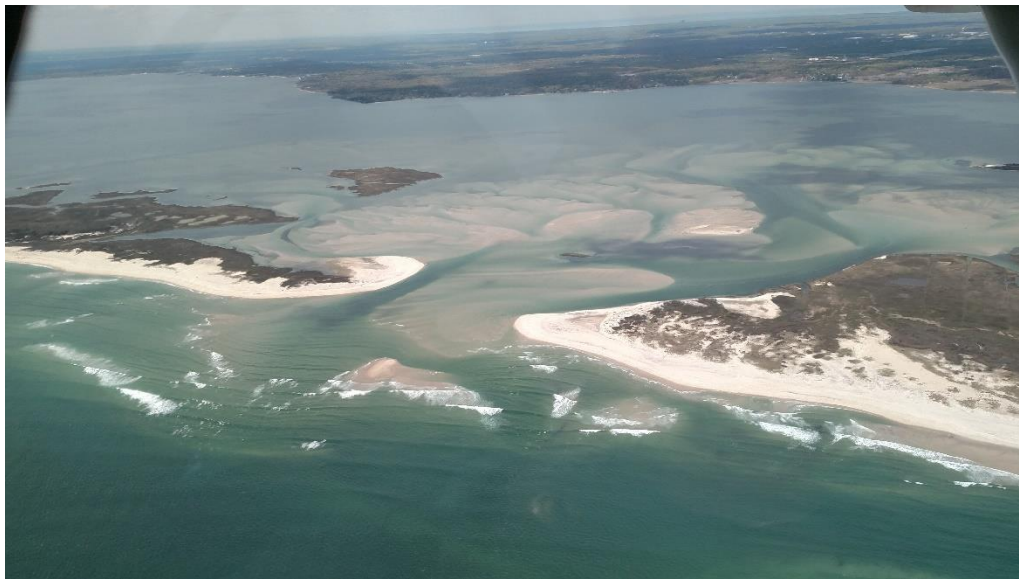
Figure 2b, Oblique aerial photo of the Old Inlet breach from May 10, 2017.

Another thing of note in comparing the January and May photo mosaics is the changes that took place in the offshore side of the breach. Since about March 2016 the exit channel through the breach turned east, but since April 2017 the channel has gradually shifted more southerly. And now that eastward channel is blocked by a shoal that extends above water during low tide in the ocean, Figure 2b.

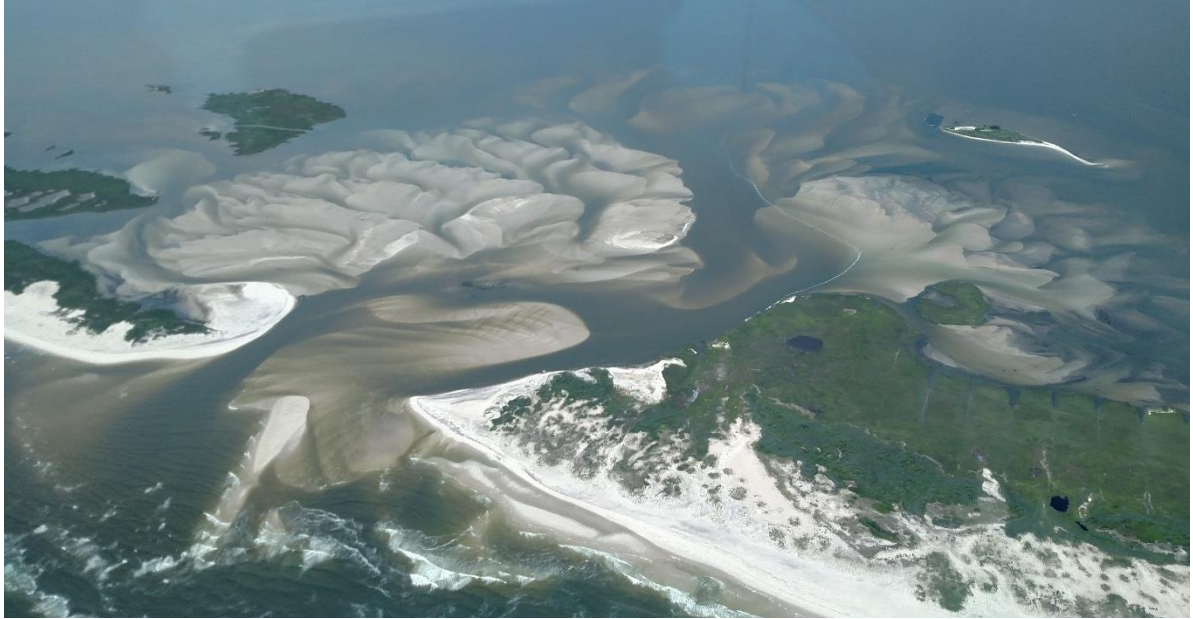
Figure 4. Oblique photo of the breach from June 22, 2017 near low tide in the ocean.

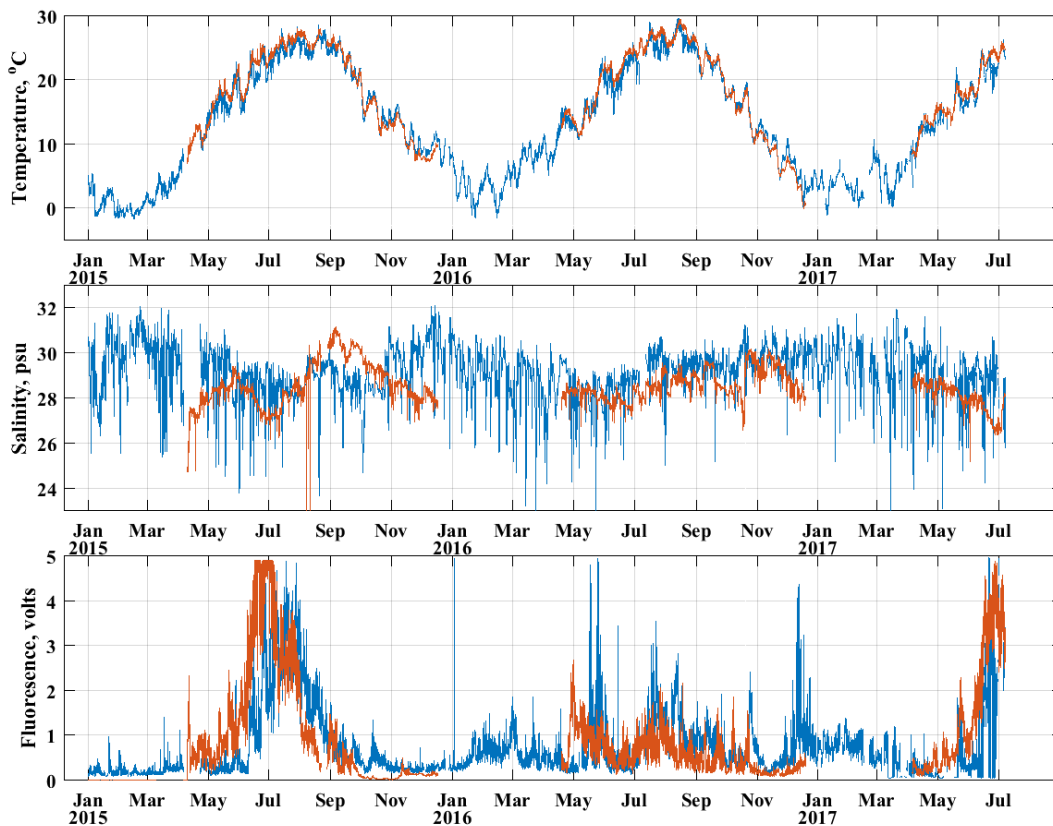
Figure 5. Time series plots of temperature, salinity and fluorescence from Bellport (blue) and the GSB1 buoy south of West Sayville (orange).

Another way to assess the condition of the breach is to see if there have been any changes inside the Great South Bay. The most immediate impact of the breach was the increased exchange between the ocean and the eastern portion of the Bay, which increased the salinity substantially from 24 to 25 psu (practical salinity units) prior to the breach to 28 to 30 psu afterwards. In the middle of the Bay at the GSB1 buoy south of West Sayville, the salinity there gradually increased as well by roughly 1 psu as a result of a change in the average current pattern that carried Bellport Bay water westward into Patchogue Bay. So if there were to be a significant change in the ocean-bay exchange through the breach, one would expect to see some sort of change in the salinity. Figure 5 shows the temperature, salinity and fluorescence records from Bellport and the GSB1 buoy for the past 2.5 years. Regarding temperature, one expects that as a result of the ocean-Bellport Bay exchange that the temperatures would be cooler in Bellport Bay relative to the central Bay during the summer, and warmer in the winter. And that is the case in past years and is still the case into July of this year and shown in Figure 5 where the orange trace from GSB1 tends to be slightly higher than Bellport's blue line.

Salinity is much more variable, especially at the Bellport marina because of the proximity of the shore, Beaver Dam Creek and Carmans River which are all sources of fresh water during and after rainfall events, Figure 5. There are clearly other longer term variations in the salinity including a seasonal fluctuation whereby salinity is higher in the winter months and lower in the spring and summer. The seasonal salinity changes make it a little difficult to discern a clear trend that might signal an altered breach. While the Bellport record is about normal for this time of the year, the record at the GSB1 buoy underwent a surprisingly steady decline in salinity from mid to late June. If that continued or the salinity remained low it would suggest a decrease in the supply of salt from Bellport Bay. But over the past couple of weeks after a period of southeast winds, the GSB1 salinity record has recovered to near normal salinities for post breach conditions. It is somewhat early days so we need to keep an eye on that record.

The lower panel in Figure 5 shows the fluorescence records from Bellport and the GSB1 buoy. The fluorometers at these locations provide an indication of how much chlorophyll is in the water produced by whatever kind of algae are present. The alga of most concern is of course the Brown Tide, whose concentration can be so great as to prevent light from reaching the sea grass and which has a low nutritive value for shellfish. As the waters warm in the spring under the right nutrient conditions, the Brown Tide bloom starts when waters reach 18 to 20°C and tapers off when temperatures reach 24 to 25°C. The fluorescence record shows the dramatic occurrence of the Brown Tide in 2015 and again this year with lower values in the spring of 2016. In general, the Brown Tide is less severe and usually of shorter duration in Bellport Bay than farther west in the central Bay. One of the benefits of the breach has been the reduction in nutrients in Bellport Bay which has lessened the impact of the Brown Tide but clearly that does not mean its elimination.
