The Impact on Great South Bay of the Breach at Old Inlet Charles N. Flagg and Roger Flood School of Marine and Atmospheric Sciences, Stony Brook University

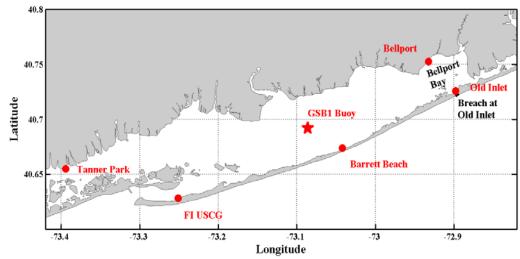
Figure 1. Map showing the location of the breach at Old Inlet, the GSB1 buoy and the sensors deployed around the perimeter of the Bay included in this report.

Since the last report was issued on January 31st there have been two significant wind events, one on January 31 with winds from the west to northwest and a second storm, which was the blizzard of February 8-9 with winds from the north to northeast. The first of these storms had relatively little impact whereas the blizzard caused significant alterations to the inlet and back bay sand shoals. The data available to document these events come from the sensors at Bellport and the Old Inlet dock, two aerial overflights and two bathymetric surveys of the inlet. The locations of the sensors deployed in Great South Bay are shown in Figure 1.

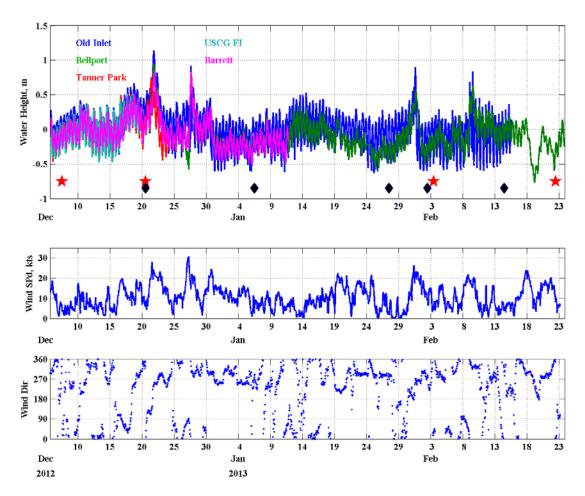
Figure 2, Time series plots of water levels and winds in Great South Bay. Also shown are the times of the bathymetric surveys of the inlet (red stars) and the aerial overflights (black diamonds).

Figure 2 shows the water level records from all the available sensors and the wind speed and direction from the GSB1 buoy. The sensors at Tanner Park, Fire Island Coast Guard Station and Barrett Beach were all retrieved and re-deployed in late December and early January leaving only Bellport and Old Inlet sensor data available over the last month. The Old Inlet sensor was retrieved on February 14 and not redeployed because the Old Inlet dock appeared to be breaking up. The water level records are all plotted relative to their long-term means. Also shown in Figure 2 are the times of the bathymetric surveys and aerial overflights.

The two high water periods in the last month were produced by different wind histories. The January 31 event with water levels reaching just short of 1 m was characterized by a prolonged period of west to northwest winds averaging over 20 kts. While the peak elevation occurred at the same time as the peak winds, the water levels dropped much faster than did the winds. Thus it appears that the initial surge in Bellport Bay was a result of the local along-bay winds driving the waters of the bay eastward, which then receded as the ocean waters offshore were set down against the island allowing the bay waters to drain through all the inlets.

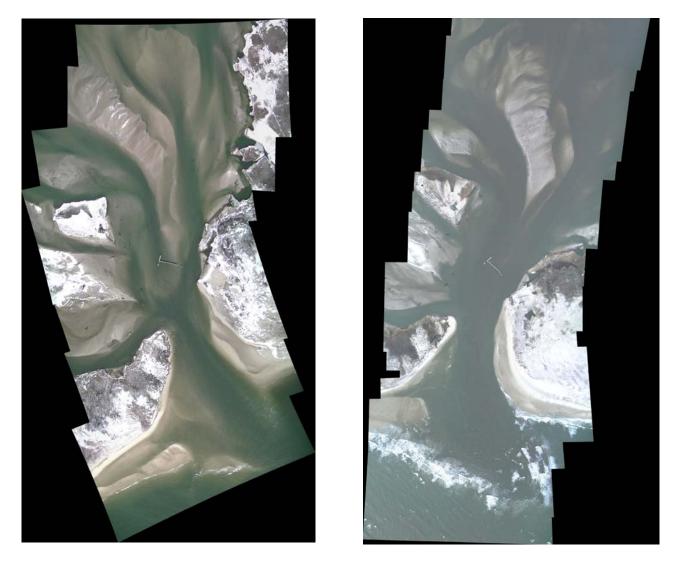
Figure 3a and 3b, Photo mosaics of the inlet taken on January 27 (left) and February 2 (right). For scale, the remains of the Old Inlet dock is about 50 m long.

Figures 3 a and b show aerial mosaics of the Old Inlet breach area, courtesy of Mark Lang, before and after the late January event. It does not appear that there were significant alterations to the inlet's inner portion from the January 31 wind event. Even the offshore bar and runnel structure and offshore bar had changed but little. (Better resolution photos are available on the Great South Bay Project web site: http://po.msrc.sunysb.edu/GSB.)

It was a completely different story as a result of the February 8-9 blizzard during which winds were initially out of the east before rotating to the north and northwest. Water levels in the bay again reached fairly high values of around 0.75 m above the long-term mean before retreating. This time it appears that the setup against the island caused by the east wind was responsible for the increased water level, overcoming the local downwind setdown in the bay. As the photo mosaic taken on February 14 shows, Figure 4, this storm caused significant alterations to the shape of the inlet, in particular to the inlet's western shore. The eastern tip of the western shore lost 30 to 50 m, and more of the western shore facing the ocean was eroded as well. With the disappearance of the eastern bar, ocean waves were able to impinge directly on the western shore of the inlet and may have been an important factor in the sudden erosion there. The bar and runnel visible in Figure 3a and 3b along the western shore had also disappeared. On the bay side, there now appears to be an larger eastern channel

south of the old dock which has extended farther into the Bay. And one can see that the middle of the old dock is missing. Subsequent visits to the area show that a large piece of the dock trails in the water and a few pilings have been pulled out. The remainder of the dock seems secure enough although the currents running past it are quite high, about 3.5 kts during flood on February 22. The western channel close to Fire Island appears to be about the same as before.

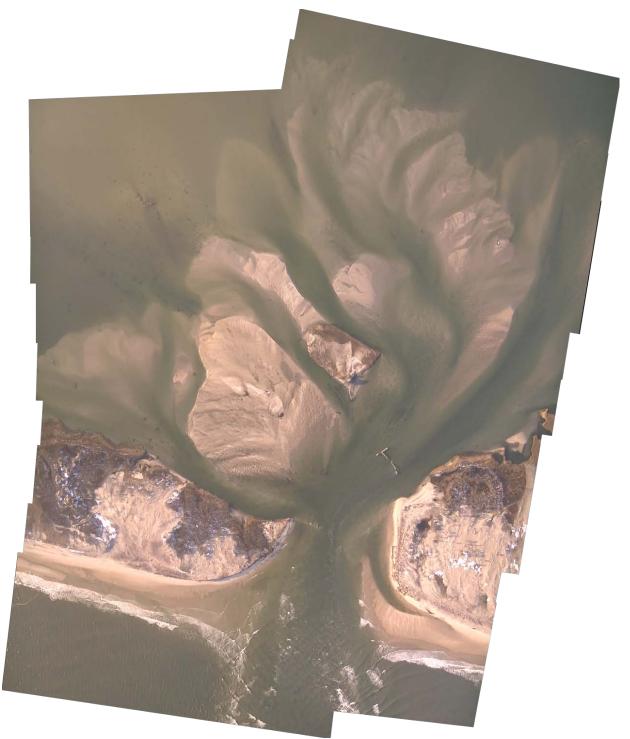
Figure 4, Photo mosaic taken on February 14 about an hour before sunset near low tide.

The air photos in Figures 3 and 4 show that there is a flood tidal delta on the bay side of the channel and an ebb tidal delta on the ocean side of the channel. We surveyed primarily in the main channel of the inlet and had a primary interest in characterizing the shape and size of this flow conduit. We also collected bathymetric data in some of the channels on the inshore flood tidal delta, but we were generally unable to survey near the offshore ebb tidal delta in our small boat because this area is often characterized by breaking waves. There appeared to be a well developed shoal on the ebb tidal delta during the Febuary 3 survey but not during the February 22 survey.

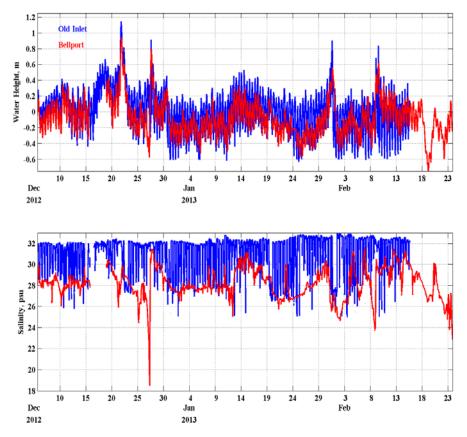
Figure 5, Time series of water level and salinities at the Bellport marina and Old Inlet dock.

With the alterations to the morphology of the inlet and presumed increase in transmittance between the Bay and ocean, an important question is whether there have been any obvious changes in Bellport Bay's tides and salinity. Figure 5 shows the entire two and one half months of the Old Inlet dock record together with that from Bellport. In the last report, we showed that there was almost no change in the February 27, 2013

An interesting feature of the water level record in Figure 5 is the period of extremely low water, about 0.75 m below the mean water level, starting on February 18 that lasted about two days to be followed by a second period of low water a day later. This event was initially accompanied by strong winds out of the northwest, but that alone does not explain what was going on since the duration was too long to be supported simply by local winds. This low water period also shows up in the ocean and can be seen in tide records from Atlantic City and Chesapeake Bay.

The last item of interest is the salinity records from the inlet and Bellport. Ocean salinity has been slightly more than 32 psu for a long time and that is reflected in the Old Inlet record during flood tides. During ebb tides, the salinity in the inlet drops to Bay salinities, which are quite variable at Bellport as winds and local runoff alter the inner Bay conditions. Soon after hurricane Sandy, salinities at Bellport reached values of around 30 psu but gradually the salinities settled to fluctuate around 27 to 28 psu. In the last month or so, the salinities at Bellport seem to have increased somewhat and now quite often reach values greater than 31 psu. The seems to indicate that there is more exchange with the ocean through the inlet even though the tide range at Bellport has not increased. At the end of the plotted record the salinity at Bellport has dropped way down to around 25 psu and appears associated with the wide spread drop in water level and may be due to a drainage of the local fresh water creeks and river. In the last day or so the salinity Bellport has recovered to nearly 30 psu so the drop in salinity was a temporary phenomena.

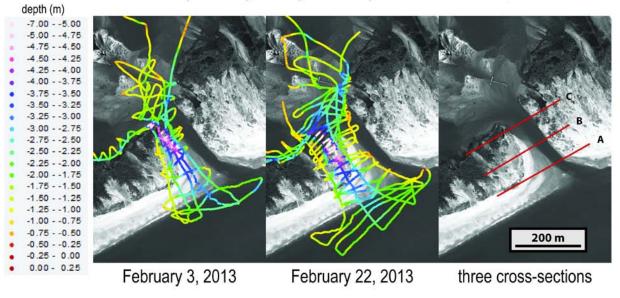
bathymetry from SoMAS, Stony Brook University base map: NOAA air photo, November 6, 2012

Figure 6. Results of bathymetric surveys conducted on February 3 and February 22, 2013. The color of the track varies with the water depth, and water depths are referenced to NAVD88.

Bathymetry surveys were conducted on February 3 and February 22, 2013 using a survey-grade echosounder and GPS navigation. Depths are referenced to the vertical datum NAVD88 which is about mean sea level in this area. Figure 6 shows the track lines and water depths recorded during the surveys.

Our bathymetric surveys show that there is a central deep channel and that the channel shoals both towards the bay and towards the ocean. On February 3, the central channel (defined here by water depths greater than 1.5 m) had a width of about 80 to 100 m with a maximum depth of about 5.8 m. The maximum depth was recorded where the channel makes a sharp turn to the west when entering the bay. The flow was very fast at this corner during the time of our survey. On February 22, the central channel had moved about 50 m to the west, had a width of about 80 to 120 m with a maximum depth of about 7.3 m. The maximum depth was recorded at the inner (bay) end of the central channel.

Cross-sectional areas were computed along three lines across the channel. Section A is near the ocean end of the channel, section B is at about the center of the channel, and section C is near the bay end of the channel. The locations of the cross sections are shown on Figure 6 and the sections are plotted on Figure 7. The cross-sectional areas for areas deeper than 1.5 m are shown in Table 2.

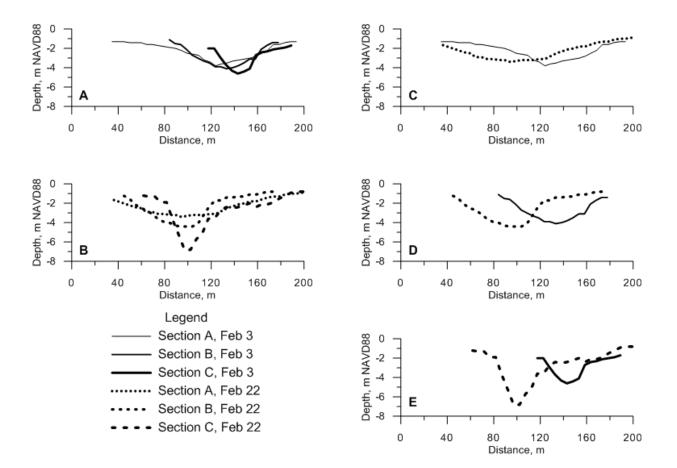
Figure 7. Bathymetric profiles plotted for sections A, B and C. A: All profiles for February 3, 2013. B: All profiles for February 22, 2013. C: All profiles on Section A. D: All profiles on Section B. E: All profiles on Section C. Horizontal distance increases towards the east.

The profile plots for February 3 and February 22 show that the inlet generally narrows and deepens towards the bay. For both surveys, the cross-sectional area deeper than 1.5 m is about the same on sections A and B, but it decreases at section C on February 3 while it increases at section C on February 22. The profiles at sections A and B are quite similar for the two surveys, although the channel is displaced to the west and the cross-sectional areas deeper than 1.5 m are 10% to 20% larger on the later survey. The lateral migration of the channel suggests that, for this time interval, sands are filling in the channel on the east side while the channel is being cut into new material on the west side.

The profile at section C on February 22 extends much deeper than the profile on February 3, and as a result the cross-section area for C on February 22 is about 80% larger than that on February 3. The increase in cross-sectional area from sections A and B to Section C on February 22 should result in a decrease in flow velocity at section C which is inconsistent with the increased apparent erosion at

section C. The larger area and deeper channel at section C on February 22 could occur if the deeper part of the channel was being cut into finer-grained sediments, for example back-bay muds or peats, rather than sands. There is some anecdotal evidence from our survey for fine-grained sediments underlying coarser sediments in the survey area, including (1) echosounder profiles often show vertical edges where depth suddenly changes by 0.5 to 1 m and such edges would be consistent with erosion through a sandy veneer into a muddy layer, possibly followed by more sand deposition in the eroded area, (2) echosounder profiles in some areas show regular features, possibly sand waves, lying on a flat reflector which would be consistent with sand being transported over pre-existing muddy sediments, and (3) one can often punch through a somewhat resistant surface layer with a pole or on foot suggesting again sand over mud.
