**Series of Aerial Photos of the Breach at Old Inlet**  
**Charles Flagg**  
**School of Marine and Atmospheric Sciences, Stony Brook University**

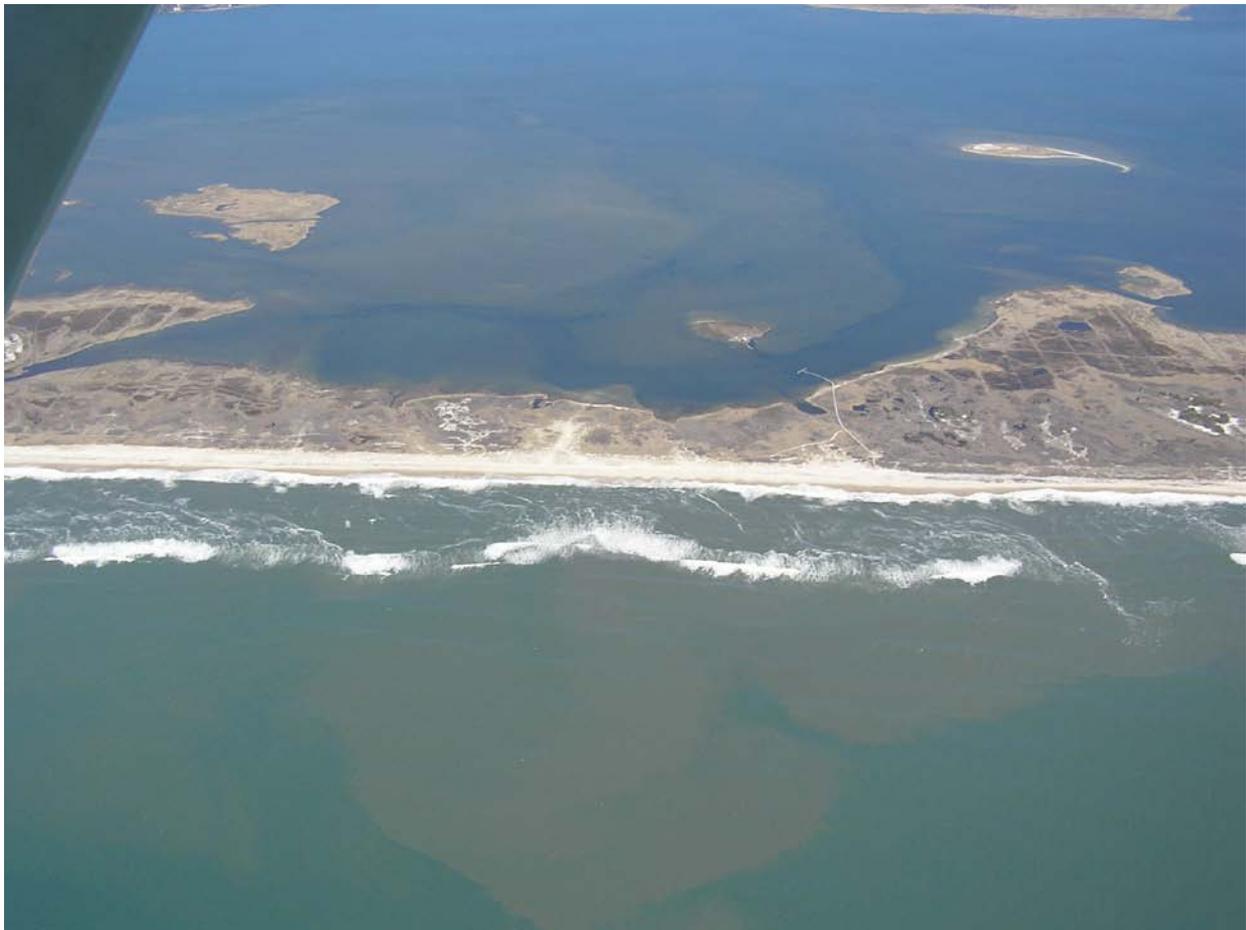
**Figure 1. Aerial photo of the Old Inlet area taken by C. Flagg in April 2005.**

Below are a series of aerial photographs that show the evolution of the breach at Old Inlet from shortly after its inception during super storm Sandy on October 29, 2012, to the latest photos taken January 6, 2013. For orientation, the first photo taken in April 2005 shows the configuration of the Old Inlet area prior to the breach. In the right-center of the picture, the Old Inlet dock and board walk across the island are visible as is a small embayment that had historically been used to tie up a ferry to bring people to the old beach clubs that were in that area. The inlet formed in area of the embayment and took out the entire boardwalk and part of the dock.

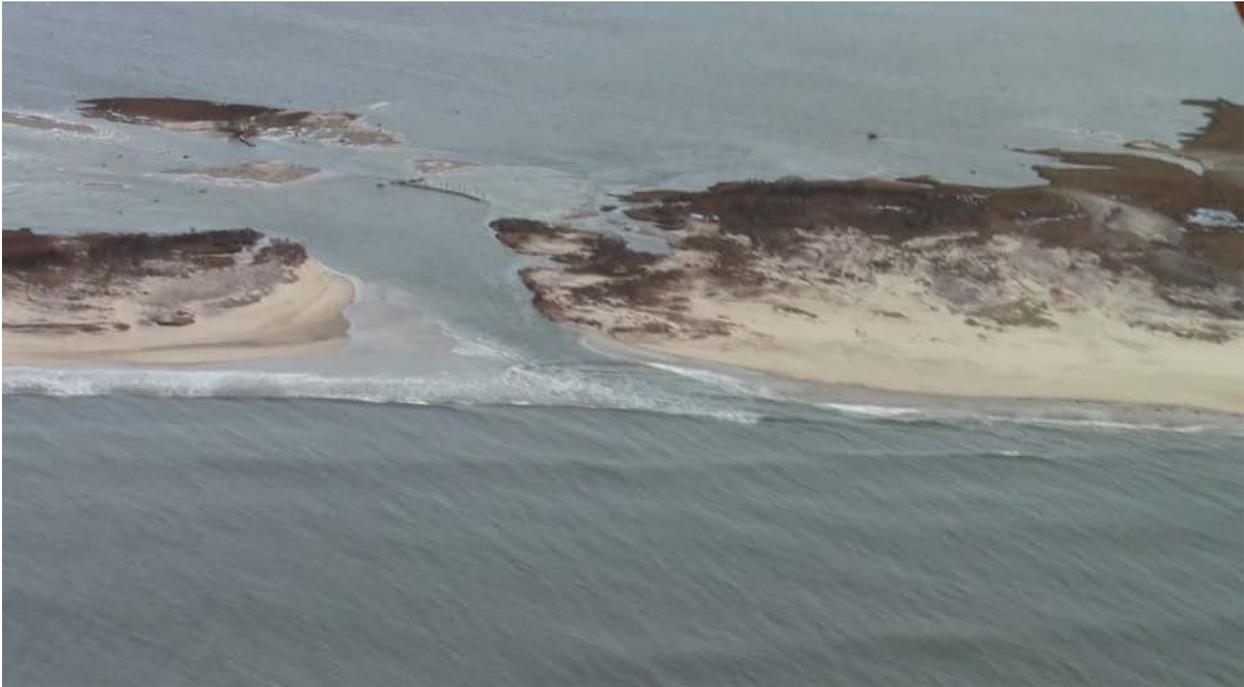
**Figure 2a.** Aerial photo taken by C. Flagg and R. Giannotti on Nov. 3, 2012, from the south of the breach.

**November 3, 2012.** The two photos below were taken on November 3, 2012 near 12:30 GMT, five days after the breach was formed. These are close up shots from the south and southwest of the new inlet in which you can see the breach, the Old Inlet dock that is no longer attached to the island, Pelican Island in the background, and several new sand islands to the north and west. All the photos were taken during flood tide. The new channel swept in from the east and hugs the east side of the breach before most of the flow turns west, south of the new sand islands.

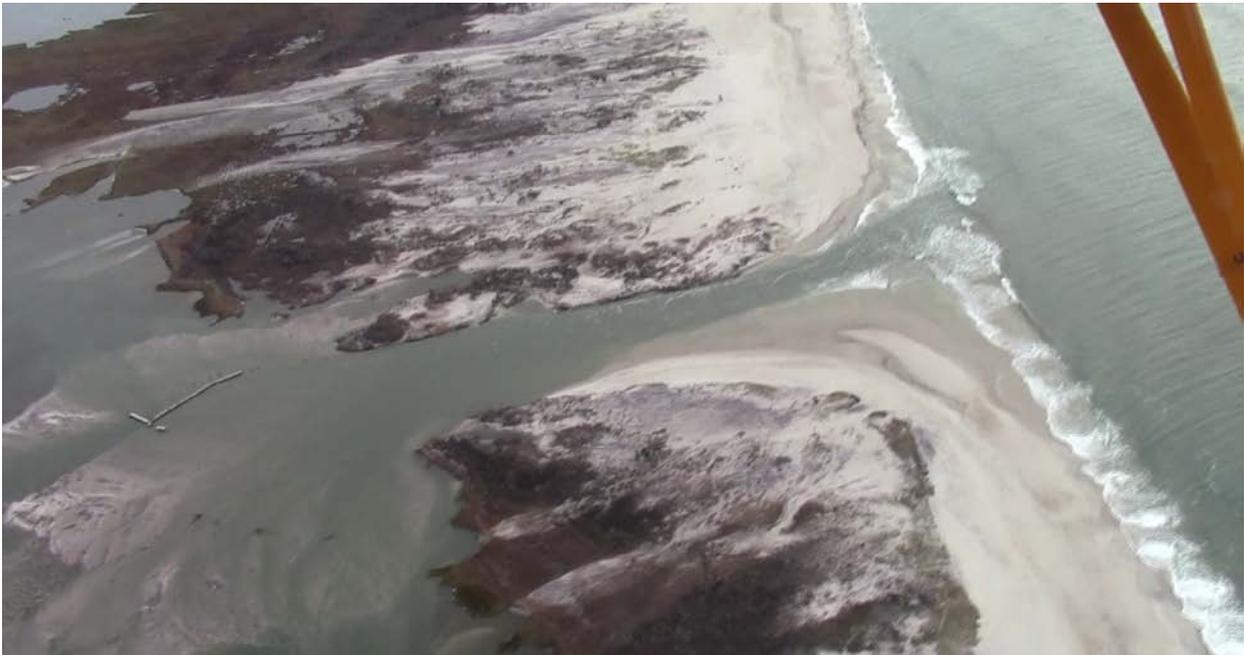
**Figure 2c. Aerial photo taken by C. Flagg and R. Giannotti on November 3, 2012, from the west of the breach.**

The last in this series of November 3 photos was taken from nearly directly overhead and clearly shows the relationship between the breach channel and the familiar landmark of the dock.

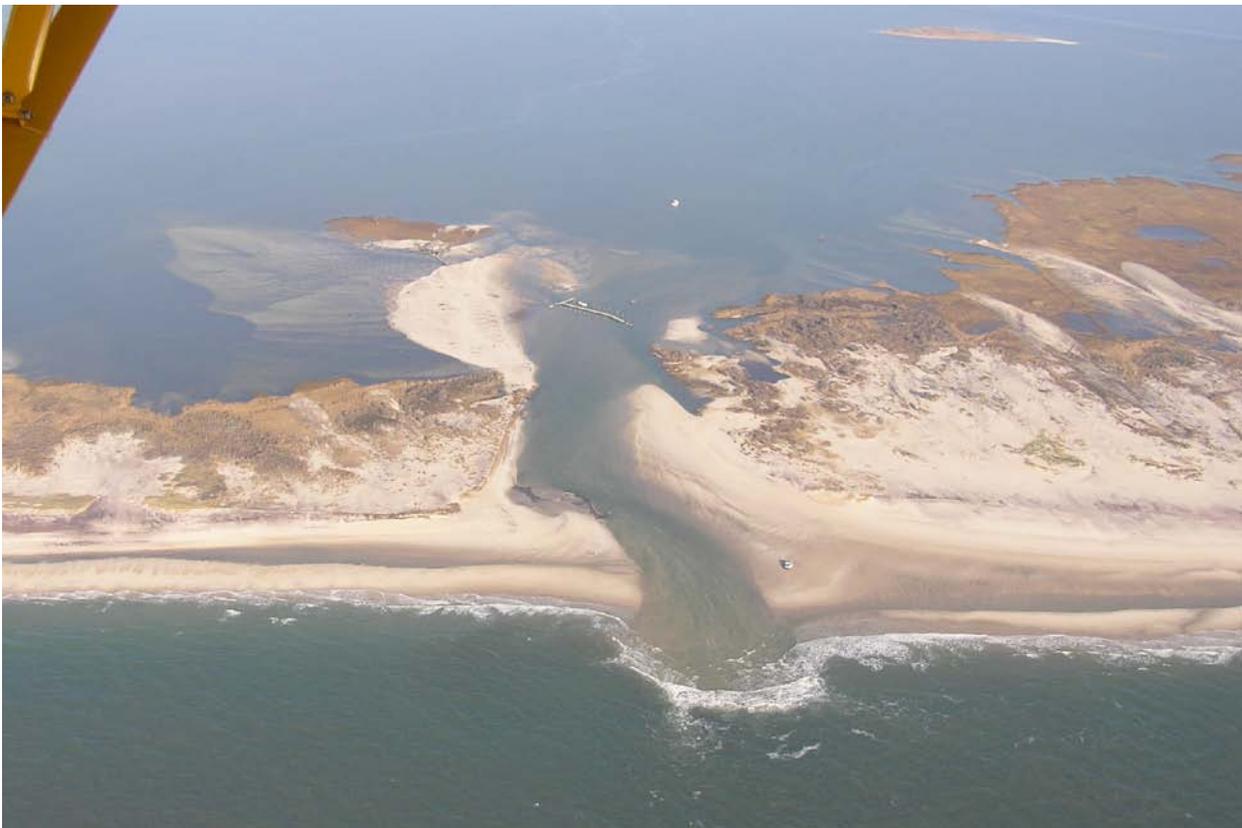
**Figure 3. Aerial photo taken by C. Flagg and R. Giannotti on November 11, 2013.**

**November 11, 2012.** A series of aerial photos, Figure 3, were taken a week later on November 11, 2012 around 1400 GMT, after a nor'easter passed through the area on November 7 and 8. There were substantial changes to both the main channel through Fire Island and the sand islands in the bay. The initial cut through the island had been fairly straight with the deepest part along the eastern edge. As a result of natural adjustment but probably mostly as a result of the nor'easter, the channel now has a decided offset to the west between the ocean and bay ends of the channel. The offset appears confined to the bay end of the channel while the ocean end does not seem to have moved. Also there is less evidence of a single deep channel.

The most visible changes to the breach occurred in the sand islands that had been formed by dune sands carried into the bay. Right after Sandy, the sand islands were north of Fire Island and west of the inlet with channels between the sand islands, Fire Island and Pelican Island. After the nor-easter the connection with the bay, which had been to the west just north of Fire Island, had completely switched directions and now makes a connection to the old Old Inlet channel to the east, passing under and through the dock as shown in the last photo below. As part of this change was the build-up of what appears to be a fairly high sand island that all but connects Fire Island to Pelican Island with a small channel that passes under the Pelican Island dock. This change in flow pattern now connects the inlet to the rest of Great South Bay through a deeper channel with greater conveyance and that may extend the natural lifetime of the inlet.

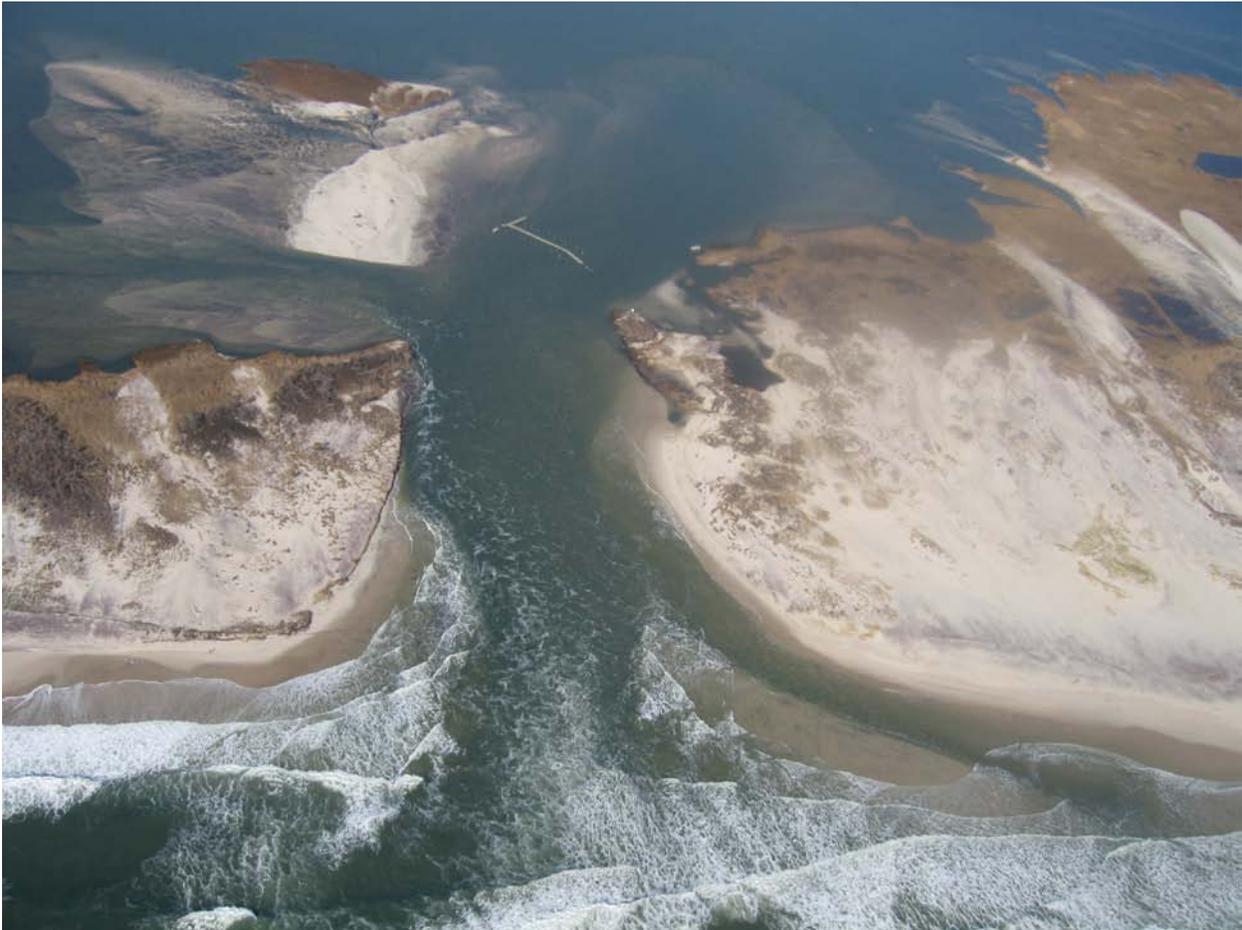
Figure 4. Aerial photo taken by R. Weissmann and R. Giannotti on November 18, 2013.

**November 18, 2012.** A follow-on set of photos, Figure 4, were taken on Sunday November 18th between 1700 and 1800 GMT. The November 18<sup>th</sup> photos show that the original channel to the west, just north of Fire Island, had been re-established although much of the sand bar to Pelican Island remained. The western edge of the inlet near the ocean has eroded to the point that the offset on November 11<sup>th</sup> had disappeared and the ebb-tidal delta clearly exhibits east and west channels connecting the inlet to the ocean.

**December 20, 2012.** The next set of photos were taken a month later on December 20, 2012 between 1620 and 1700 GMT. Meteorologically, not much had happened between the November 18 and December 20 photos, so there was a more gradual evolution of the inlet as shown by a comparison between Figures 4 and 5. The most notable change was the disappearance of the sand island south of Pelican Island, and the channel to the west, which had been along the north shore of Fire Island, moved north closer to Pelican Island. There also were changes to the inlet. The eastern side of the inlet had migrated somewhat to the west. A bit of a bar had formed off the east side shown by the breaking waves. And the low sand beach along the western side had eroded away. The ebb shoal delta again visible in the area of breaking waves and the east and west channels are also evident.

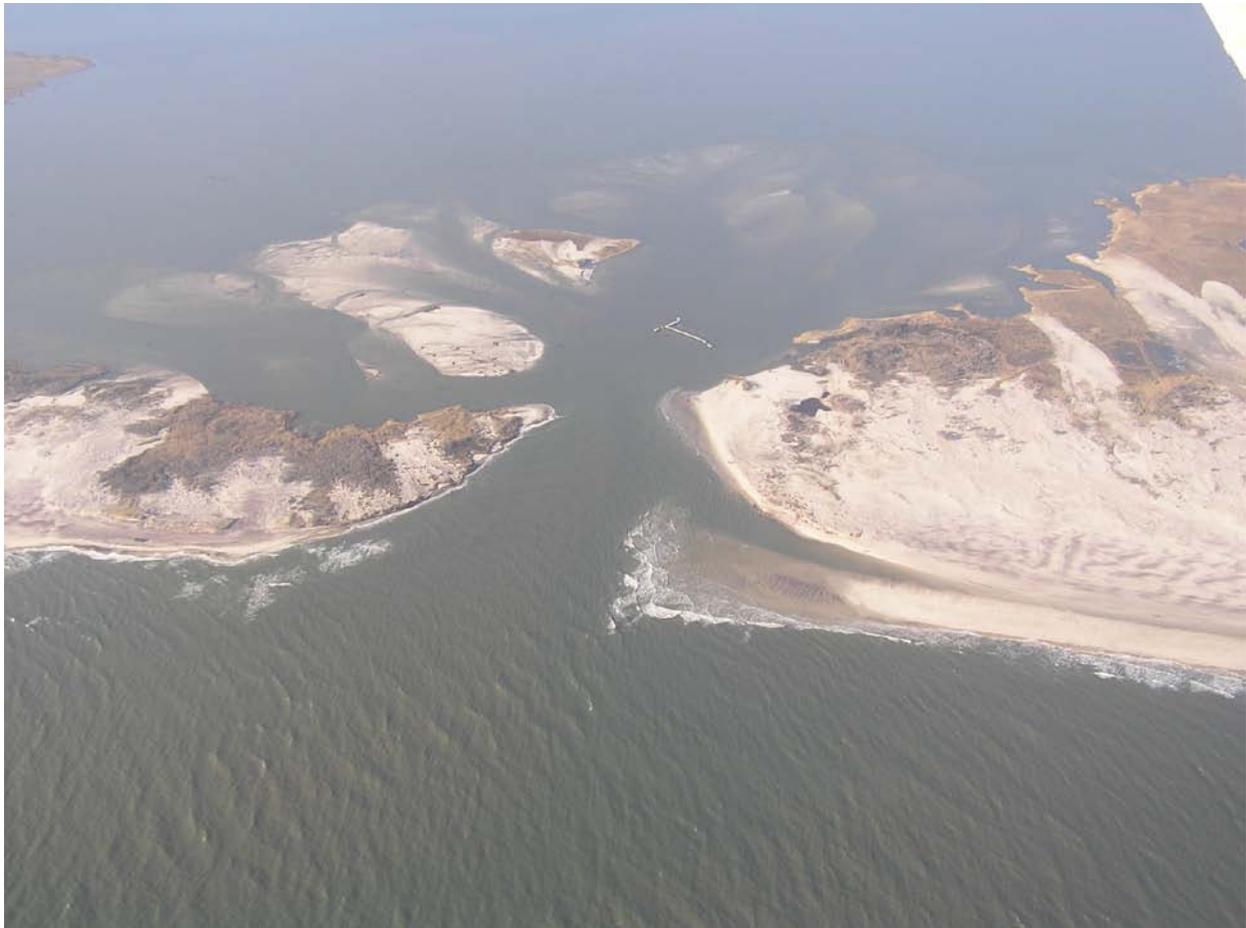
**Figure 6. Aerial photo taken by J. Flagg and C. Flagg on January 6, 2013.**

**December 22, 2012 – January 6, 2013.** In late December, there were a couple of storms that have again altered the configuration of the inlet at both the ocean and bay ends. On December 22 and 23, there was a sustained period of high westerly winds, which caused a significant water level rise in Bellport Bay. This event was followed a few days later by the passage of a nor'easter on December 27, which caused a second period of high water level. The combination of these storms have resulted in quite noticeable changes in the configuration of the inlet and the back bay channels, as shown by photos taken on January 6, 2013 around 2000 GMT, shown in Figure 6.

Along the ocean beach to the east of the inlet, an offshore bar formed that moved onshore creating a series of ridges and runnels that eventually connected to the ebb shoal. The ridge/runnel system extended all along the beach to the east, and so was not particularly associated with the inlet morphological dynamics. However, as the offshore bar moved onto the beach, it cut off the east channel and forced all the tidal flow to use the west channel, which caused it to enlarge and move into the center of the inlet. As part of that process, it appears that the ebb shoal delta has eroded away. At the same time, there was significant deposition along the eastern edge of the inlet especially at the northern end. Along the western edge of the inlet, there has been considerable erosion with the shoreline moving up to the scrub line.

In the back bay area, a substantial sand island has formed causing the formation of two channels to the west, one along the west side of Pelican Island and second one just north of Fire Island.

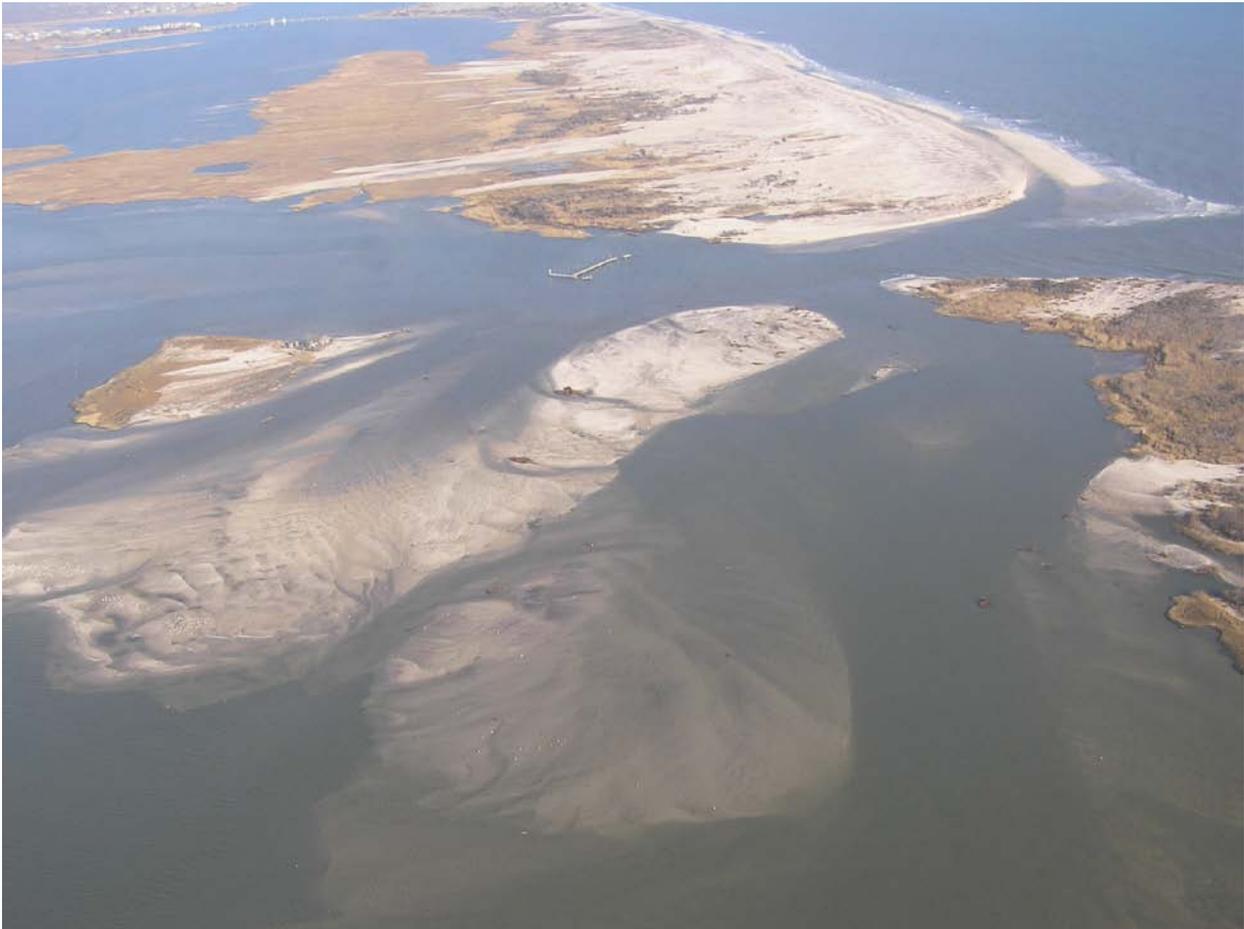
The clarity of the water made the underwater shoaling to the north of the inlet visible in a couple of the photos taken on January 6<sup>th</sup> and two of these photos are shown in Figure 7. The sand island and shoaling that extends off to the northwest of the inlet is at least 0.5 km long, while the shoals to the east of Pelican Island extend about 0.6 km from the inlet.

**Figure 7a. Aerial photo of the inlet from the northwest showing the extended sand island and shoals to the west of the inlet. Photo taken by J. Flagg and C. Flagg on Jan. 6, 2013.**

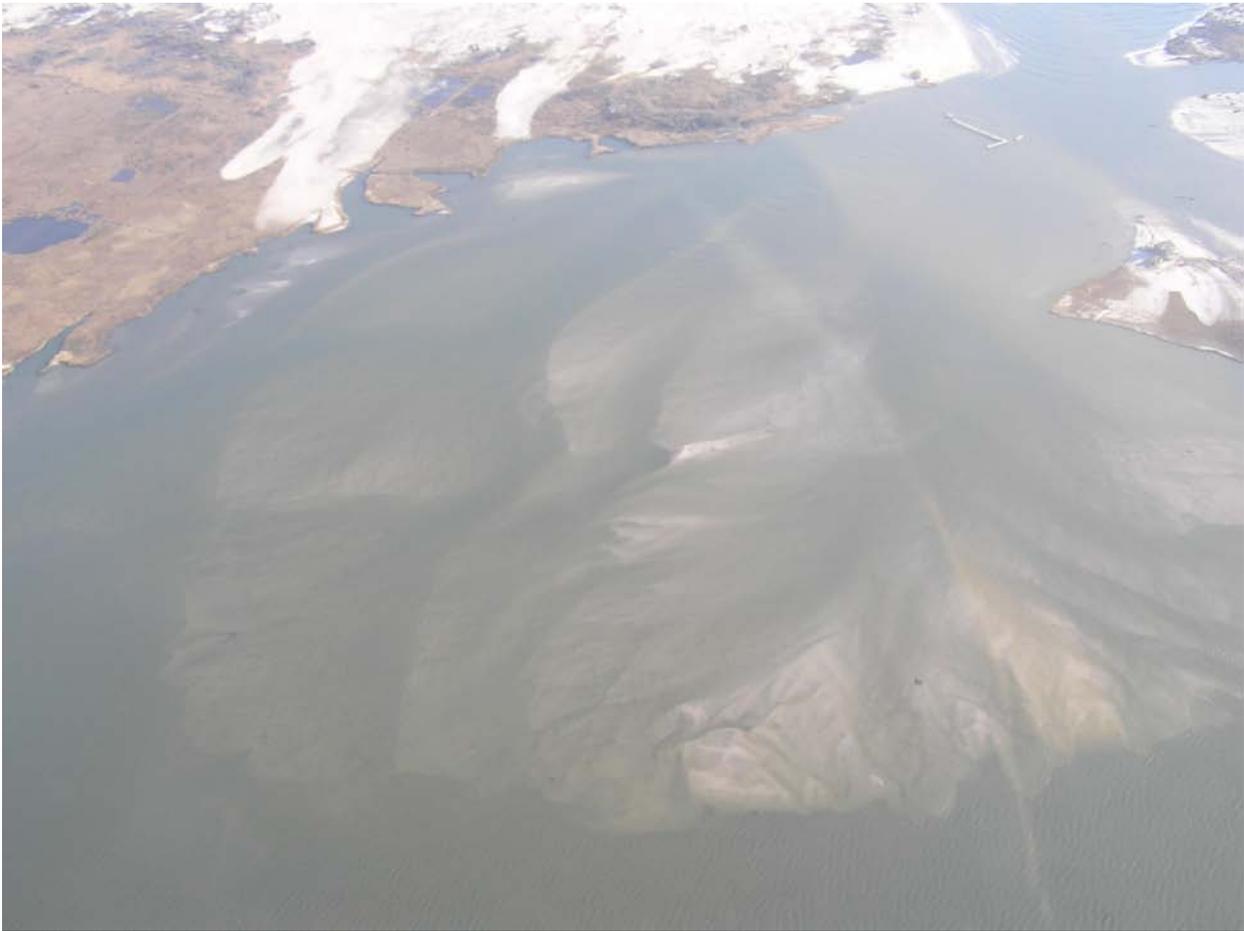
**Figure 7b. Aerial photo of shoals to the northeast of the inlet. Photo taken by J. Flagg and C. Flagg on January 6, 2013.**
